Hazard Alert

Power Take-Off

Hazard Summary

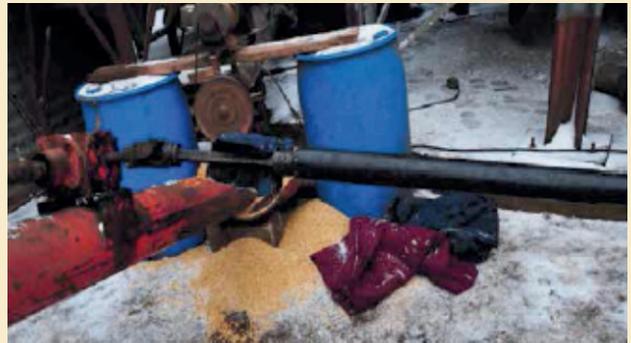
In November 2013, a farm worker was unloading a tank of soybeans at a farm when he fell into the Power Take-Off (PTO) driveline of a grain auger. The universal joint of the PTO was not properly guarded and the worker became entangled in the PTO driveline, resulting in extensive injuries. Injuries included a fractured left arm, punctured lung, fractured ribs, and a severed spinal cord resulting in paralysis of the legs.

- The universal joints on both ends of the PTO shaft were exposed due to inadequate guarding.
- The auger was not equipped with the implement shield, which should be attached to gear box, as is recommended by the manufacturer.
- Slippery conditions due to cold weather and snow.
- The proximity of the worker to the PTO while it was operating.

- Make sure that the PTO is properly maintained and that PTO drivelines are fully shielded.
- Regularly check all components of the PTO guarding system for nicks or damage.
- Make sure that all sections of the PTO driveline, including universal joints, are fully shielded. PTO guards should include a tractor shield, a shaft shield and an implement shield.
- Replace or repair damaged shields, bearings and safety devices before the equipment is used.
- Make sure that PTO driven equipment is maintained and guarded according to manufacturer's recommendations.
- Never operate equipment with damaged or missing PTO guards.
- Stay well clear of rotating PTO drivelines.
