# Hazard Alert

## HAZARD SUMMARY

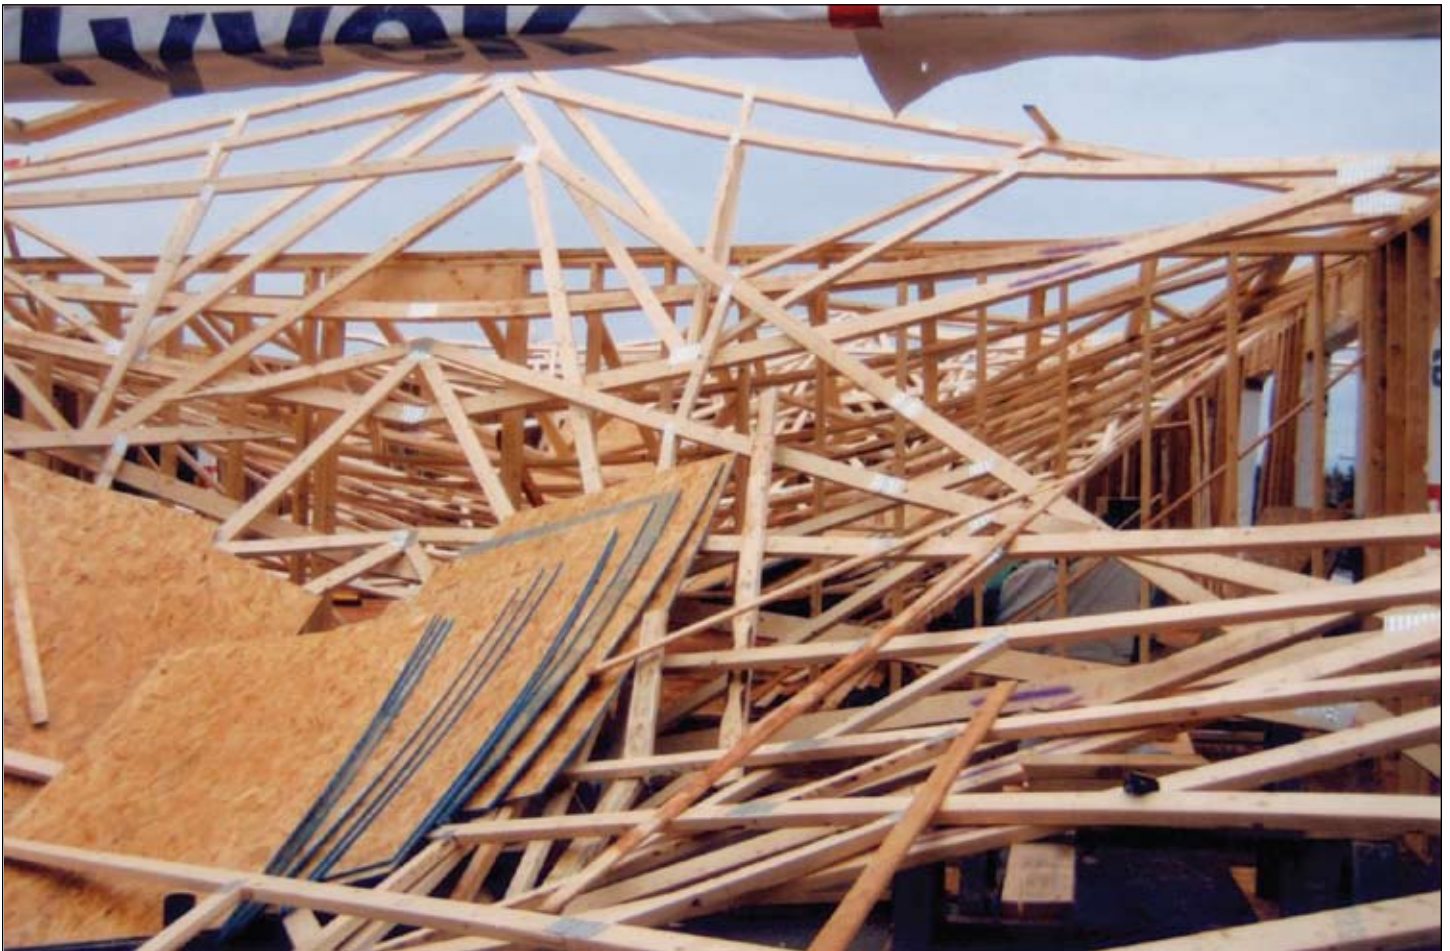
Recently, two Island workers were injured as a result of a roof truss collapse during construction of a new home. The truss system had been installed and braced, and ready for sheathing. Soon after several piles of sheathing had been loaded onto the truss system, it became clear that the weight was more than individual trusses were designed to support. The loaded trusses began to roll horizontally, collapsing the entire system, causing injuries to the workers.

Manufacturer's recommendations were not followed when individual trusses were overloaded with construction material that weighed more than the trusses could support.

- 1). Employers must ensure that workers understand and follow procedures supplied by the truss manufacturer on handling, erecting, positioning, and bracing trusses.
- 2). Employers must ensure that truss erection is directed by a "competent" person under the Regulations, who is appropriately qualified based on training, experience, and knowledge of the Act and Regulations.
- 3). Employers must ensure that trusses are properly braced to maintain structural capacity and stability.
