HAZARD

Alert

OYSTER BARGE CRANE BOOM FAILURE

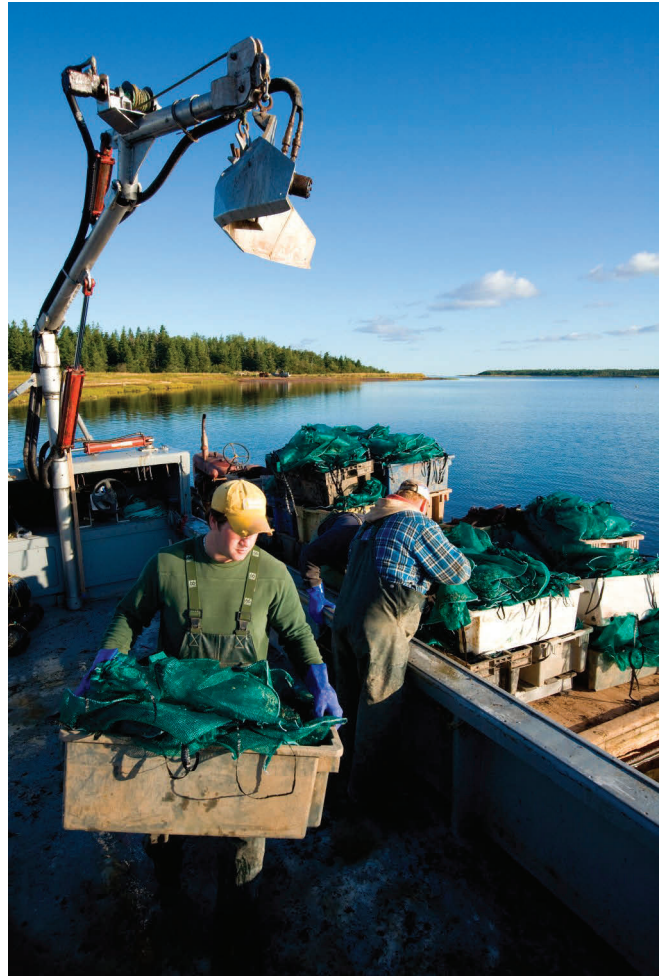
Industry photo courtesy of John Sylvester
